CITY OF HUNTSVILLE VISITOR CENTER EXPANSION

Facility Assessment
October 30, 2015

PGAL

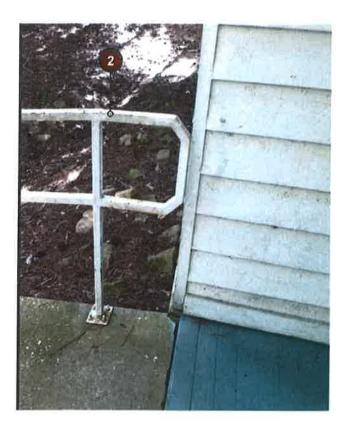
Figure 7-1-3Exterior Southwest Site at Parking

- CONDITION: Parking not ADA compliant REPAIR: Provide compliant parking spaces
- CONDITION: Non-code compliant handrail.

REPAIR: Replace with code compliant handrail.
- CONDITION: Site furniture not matching.

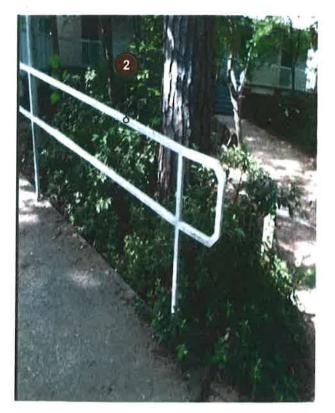
Figure 7-1-4
Exterior Southwest Site at Parking

REPAIR: Provide matching site furniture for coherent aesthetic.
- CONDITION: Missing masonry caps on site wall. REPAIR: Replace.
- CONDITION: Leaves collected on roof
 REPAIR: Periodic removal of plant materials on roof

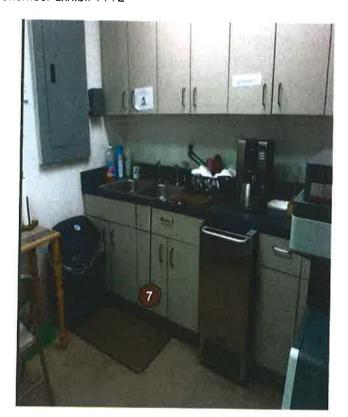
Figure 7-1-22 Break Room V110

- CONDITION: Incandescent lights required constant replacement.

The building electrical systems are performing as required. Additional electrical capacity for programming is desired. The electrical panels are close to being at maximum circuit capacity. The existing incandescent spot lights in the chamber exhibit and gift shop constantly needs replacement. New long life LED lights are recommended.

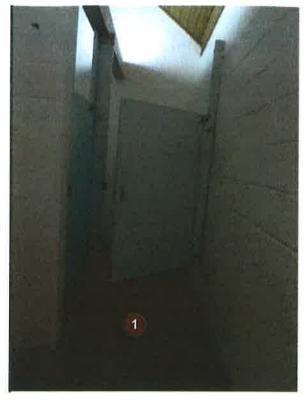
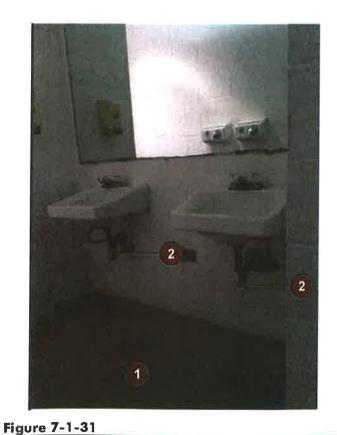
Figure 7-1-30 Men's Room V115

REPAIR: Clean and coat with water repellent coating or tile. Provide weep holes and / or seal building.
- CONDITION: Sink pipes not covered per ADA. REPAIR: Provide pipe covers.
- CONDITION: Hand dryer protrudes more than 4" from wall in path of travel not ADA compliant.

REPAIR: Provide ADA compliant hand dryer.
